Comprehensive Energy Audit  
of  
Barrow Heavy Equipment Shop  
3427 C Street  
Project # ASRC-BRW-RSA-03B

Prepared for:  
The North Slope Borough  
Department of Public Works  
September 9, 2011

# Barrow Heavy Equipment Maintenance Shop Comprehensive Energy Audit

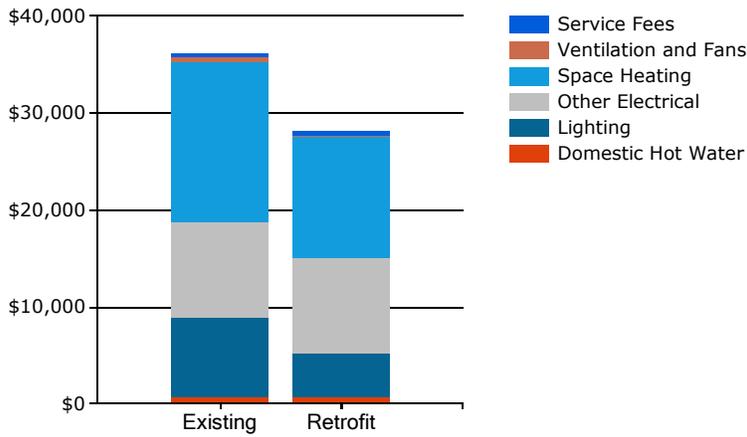
Annual Energy Costs by End Use

Description	Space Heating	Space Cooling	Water Heating	Lighting	Other Electrical	Cooking	Clothes Drying	Ventilation Fans	Service Fees	Total Cost
Existing Building	\$16,506	\$0	\$603	\$8,242	\$9,968	\$0	\$0	\$494	\$409	<b>\$36,223</b>
With Proposed Retrofits	\$12,594	\$0	\$617	\$4,589	\$9,784	\$0	\$0	\$148	\$409	<b>\$28,141</b>
SAVINGS	\$3,911	\$0	-\$14	\$3,654	\$185	\$0	\$0	\$346	\$0	<b>\$8,082</b>

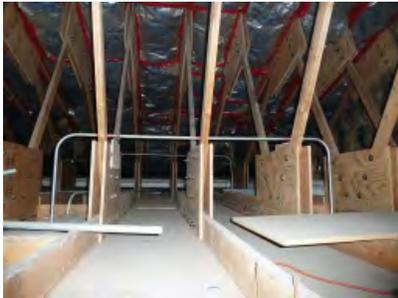
Attic with R-19 at roof underside

Rank	Location	Existing Type/R-Value	Recommendation Type/R-Value	Installed Cost	Annual Energy Savings
10	Ceiling w/ Attic: Shop Attic	Framing Type: Standard Framing Spacing: 24 inches Insulated Sheathing: None Bottom Insulation Layer: None Top Insulation Layer: R-19 Batt:FG or RW, 6 inches Modeled R-Value: 21.1	Add R-19 fiberglass batts to attic with Standard Truss.	\$28,621	\$380

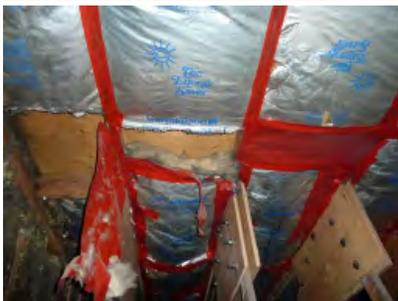
Damaged insulation in attic

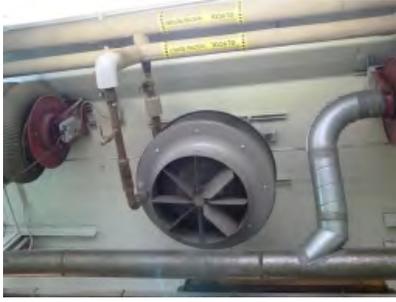
Vertical unit heaters typical of all

- a. Heating System:** The building heating system consists of two Weil McLain 1,674 MBH cast iron gas fired boilers. The boilers provide heat to six vertical unit heaters, baseboard in the offices, and air handlers.

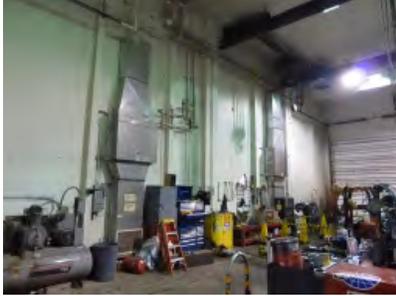
Ventilation exhaust fan

- b. Ventilation System:** There are large exhaust fans, air handlers, and gas make up air heaters in the building to provide ventilation. A specialty carbon monoxide fan provides exhaust for products of combustion when vehicles are operated for tune-up.

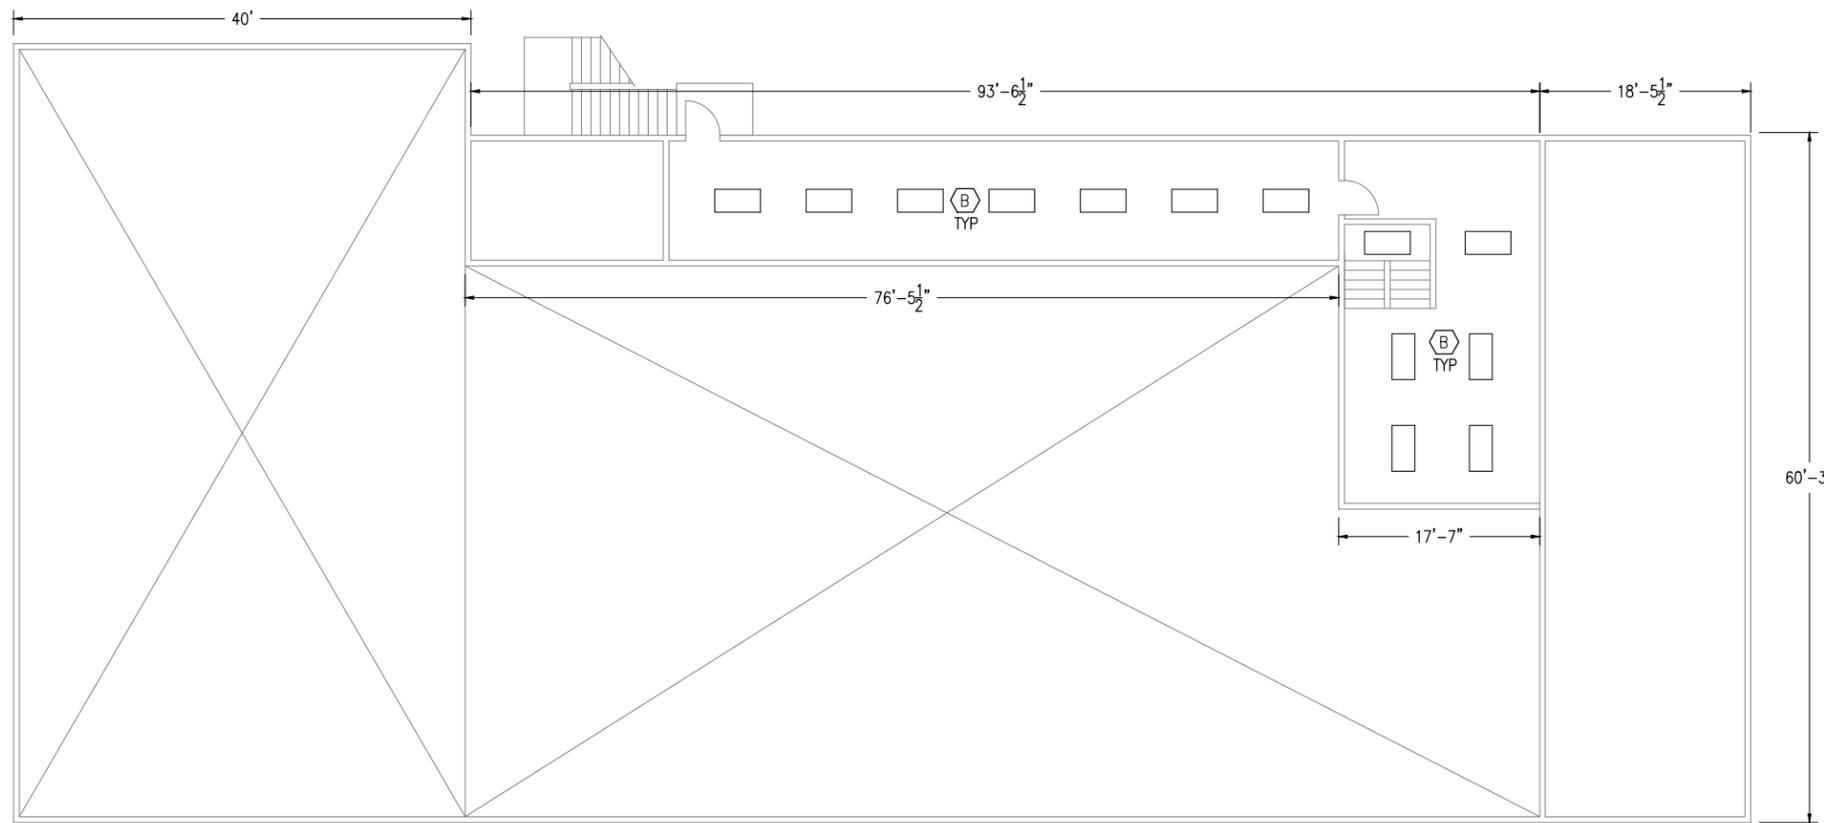
**1** 3427 C STREET - SECOND FLOOR PLAN  
1/8"=1'-0"

⬡ 2 TUBE T-12, SURFACE
